# Prominent Hall Clock in the Holden House Museum

by Randy Jaye (FL)

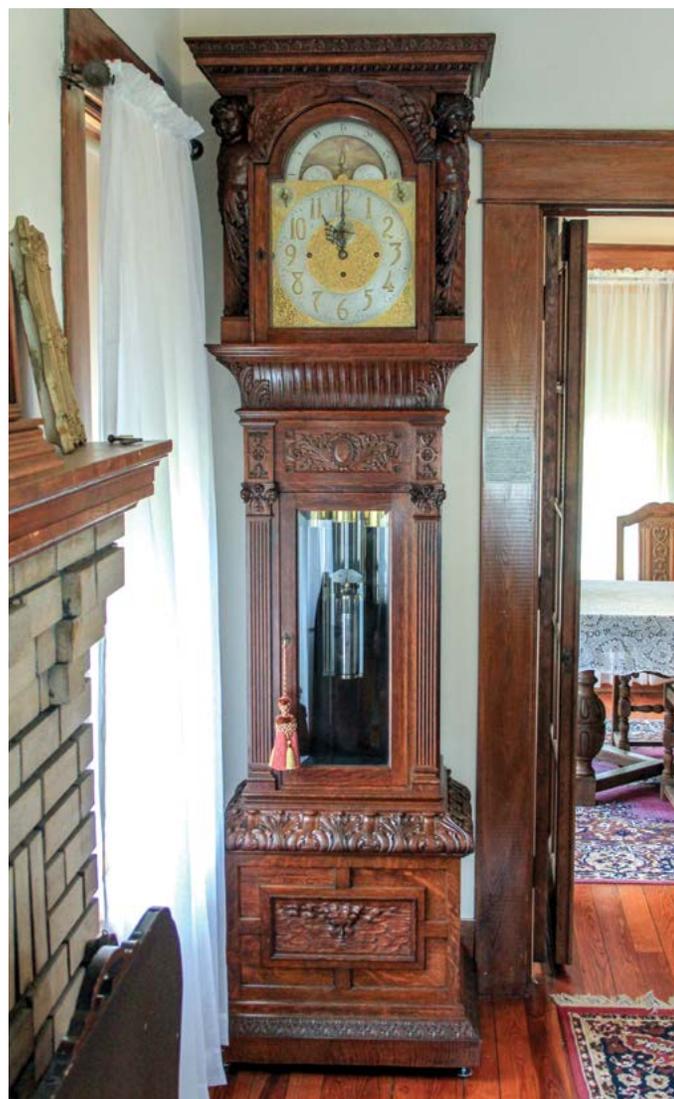
**Figure 2.** The restored Theodore B. Starr hall clock (circa 1898) now standing in its new home, the living room at the Holden House Museum. PHOTO BY RANDY JAYE.

The case also required attention. It needed an intense cleaning and slight restoration because cigarette smoke film and odor covered all surfaces. The dial required some repairs and cleaning, and all of its silvered pieces had to be restored because they had major tarnishing problems.

The oak case was hand-cleaned three times with Murphy's oil soap. The bottom section required a minor repair as the joints were re-glued and clamped back into their original alignment. Four commercial-grade leg levelers were installed. The entire case was hand-rubbed with matching stain. The two locks were removed, cleaned, and oiled. Two new skeleton keys were custom-filed and ground to fit and work with the original locks.

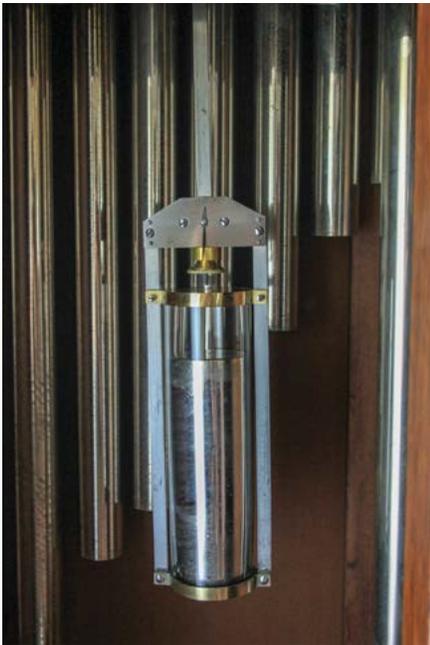
**Figure 5.** One-jar mercury pendulum. PHOTO COURTESY OF RANDY JAYE.

21. Cleaned mercury vial (noticed that the glass is chipped on top edge).
22. Cleaned mercury.

23. Added about 1/2 inch to mercury column (1.4 lb.). (Removed the small amount of mercury in base and on frame screws. Some amalgamated with brass inside the cap.)

34. Added felt pad "seal" inside mercury vial cap.
35. Evened the chipped lip of the mercury vial with epoxy.
36. Coated the face of the wood-faced strike hammer with cyanoacrylate to make a harder surface for a louder strike sound.
37. Restrung all tubular bells with heavy cotton braiding cord.

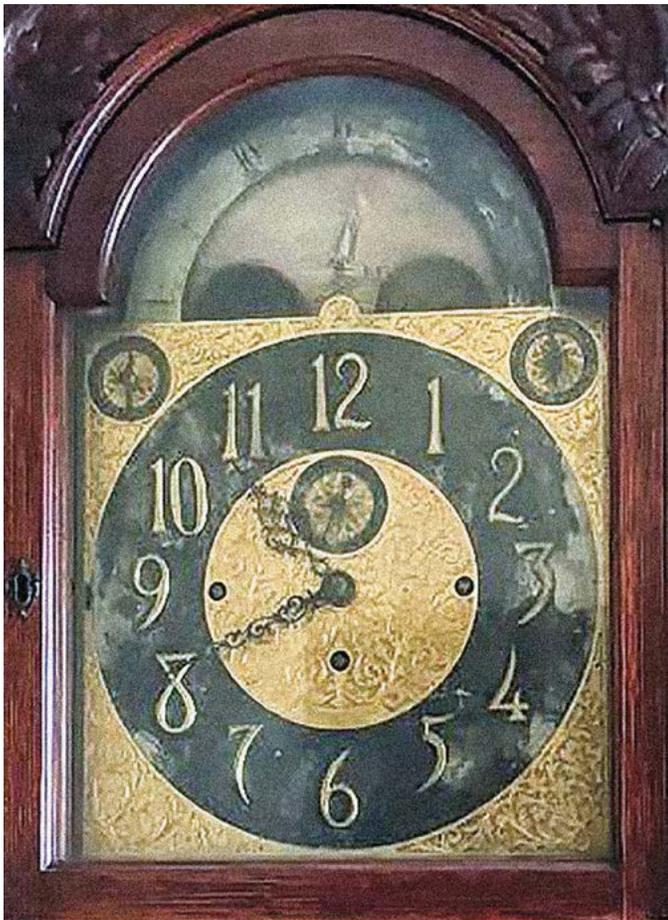
The silvered parts of the dial were heavily tarnished and could not be cleaned (Figure 10). They were removed and sent out for re-silvering. There were several other time-consuming issues that were addressed

**Figure 10.** Dial condition before restoration. PHOTO COURTESY OF PETE SCHREINER.

6. De-rusted and cleaned steel screws for mounting silvered face pieces. Polished visible screw ends to match silver.
7. Sourced all dial silvered pieces to NAWCC member Kevin Scanlan for re-silvering.

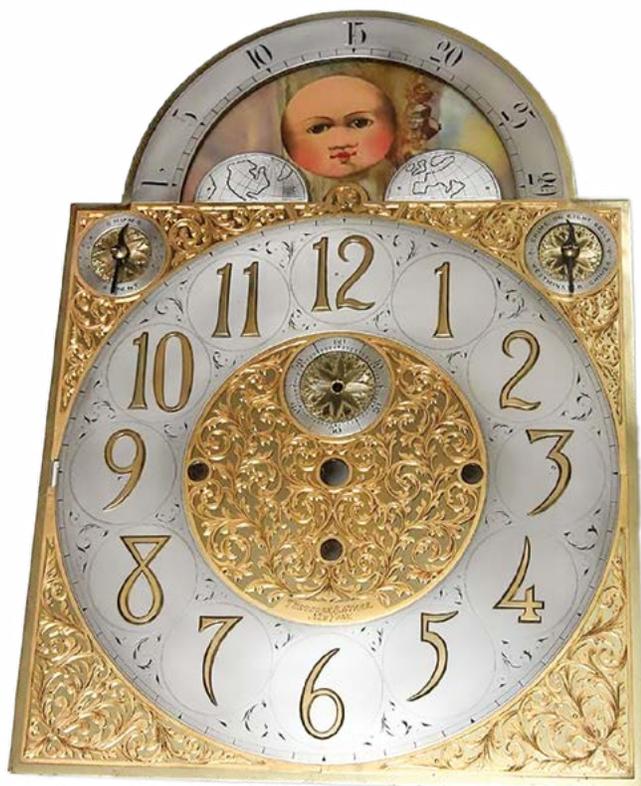
related to the dial (which has more than 140 parts including many screws). The difference in the before and after condition of the dial are like night and day (Figure 11). The moon dial's face was cleaned and is in excellent original condition (Figure 12).

**Figure 11.** Dial condition after restoration. PHOTO COURTESY OF PETE SCHREINER.

1. De-rusted, blued, and lacquered hands.
2. Repaired chime fly and solder filled base cracks. Made new washer and re-attached the vane post.
3. Made 1-64 threaded brass rod to use to replace broken or missing numeral studs.

4. Silver soldered (Stay-Brite 430F) threaded rod onto numerals, trimmed to mounting length (two blind holes next to face mounting posts).
5. Tumble cleaned and lacquered numerals.

8. Touched up stains on re-silvered face pieces.
9. Inked in letters on silvered selector rings as needed.
10. Lacquered silvered face pieces.
11. Cleaned and lacquered the brass face plate.

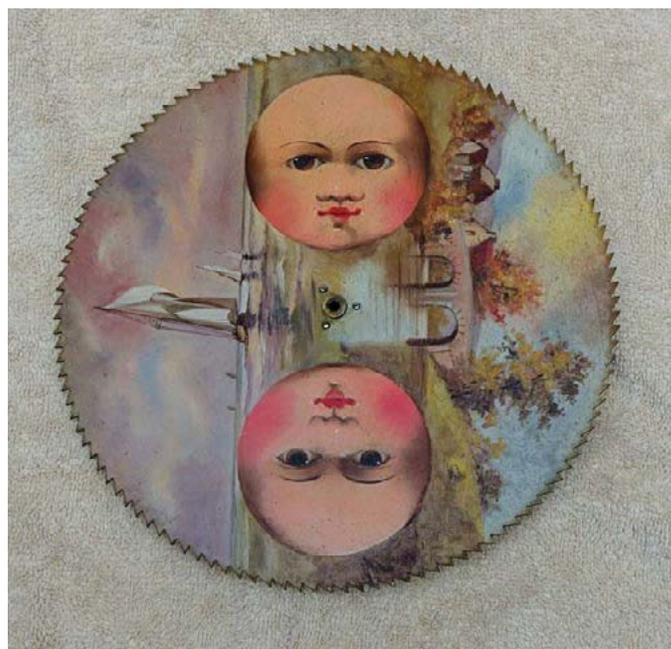
**Figure 12.** Hand-painted moon phase dial after cleaning. PHOTO COURTESY OF PETE SCHREINER.

12. Cleaned and lacquered the brass face overlays.
13. Cleaned overlay brass screws and polished visible ends.
14. Cleaned moon dial painting with Vulpex detergent.

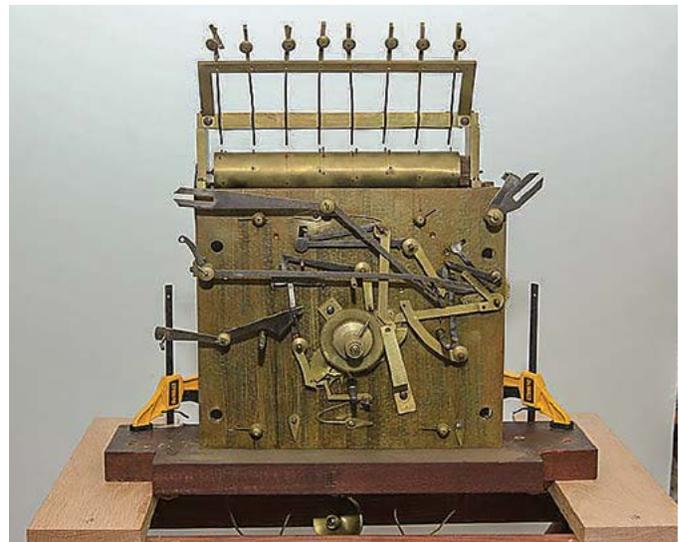
1. Three weights (right: 37 lb., 12 oz.; center: 13 lb., 6 oz.; left: 17 lb., 12 oz.) needed to be cleaned, polished, and lacquered.
2. Tubular bells tarnished, scraped and dirty – needed to be cleaned, polished, and waxed.
3. Bell hammer rack had one string attachment damaged.
4. Mercury vial and holder needed to be cleaned.
5. Movement screws were rusted.
6. Movement steel parts were rusted.
7. Rear plate – one screw is not original and needed to be replaced with correct screw.
8. Plates were discolored. (Plates weigh 11 lb., 8 oz.)
9. Many brass tapered pins used.

10. Strange heavily pitted rust on many screw heads and the steel parts of levers.
11. One lever spring was broken off.
12. Two hammer lever cord clamps were broken.
13. Chime pulley screw was broken.
14. Chime fly fan spins freely.
15. Strike fly fan mounting broken/missing collar.
16. One hammer string ring was missing.

**Figure 13.** J.J. Elliott movement on test stand during restoration. PHOTO COURTESY OF PETE SCHREINER.

1. Cleaned all parts and plates (Figure 13). Used both ultrasonic and shot-tumble cleaning process and ammoniated clean bath. Hand-rubbed many pieces with Flitz polish. Pegged out pivot holes and used thinner to remove old oil.
2. Treated flash rust.
3. De-rusted levers, pinions, and screws. (Fine grain rust pitting all over steel levers and many screw heads.)

4. Filed and polished pitted screws on a lathe. Cleaned screw slots.
5. Polished pivots as needed (all winding arbor pivots had been wrongly wire brushed or something similar.)

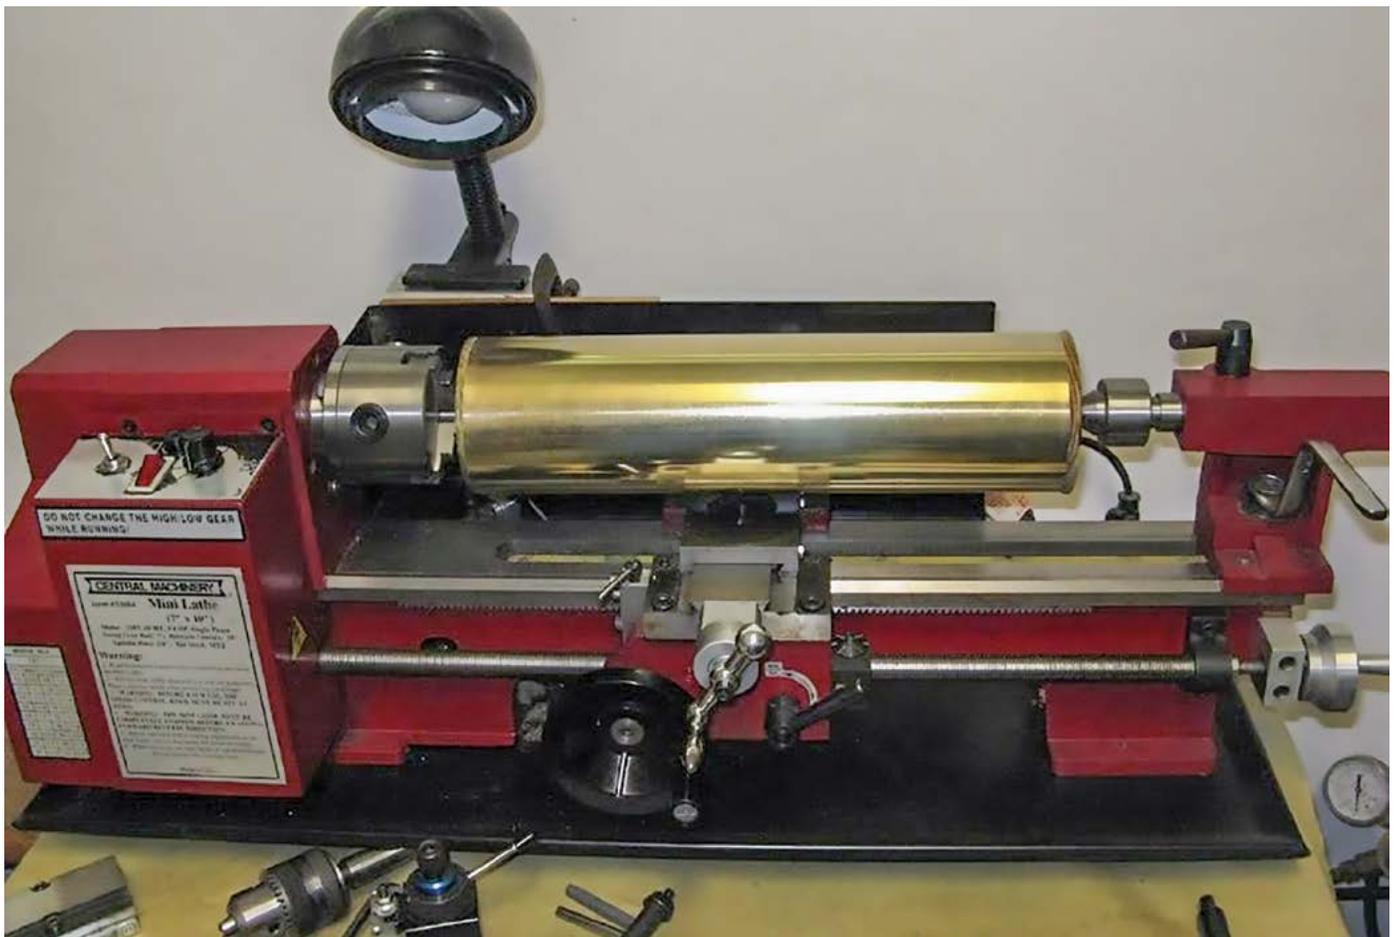
**Figure 14.** Brass weight shells on a lathe being polished during restoration. PHOTO COURTESY OF PETE SCHREINER.

6. Cleaned, refinished on lathe, polished, and lacquered weight shells (Figure 14). Note: Discovered a newspaper lining inside the weight shells.
7. Cleaned, polished, and waxed tubular bells.
