# Prominent Hall Clock in the Holden House Museum

by Randy Jaye (FL)

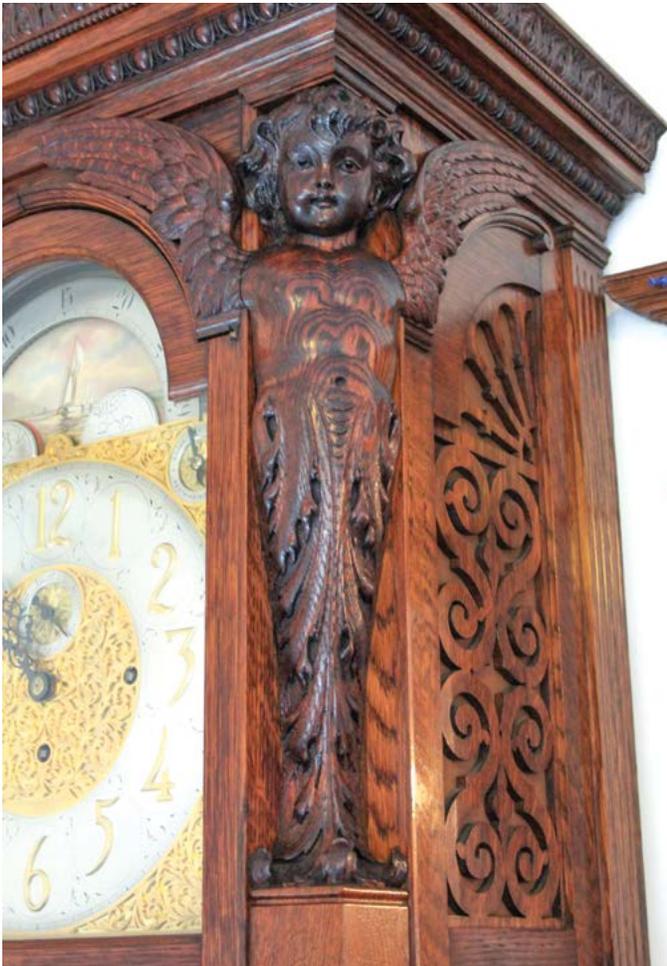
**Figure 3.** Carved angel on the right side column of the hood. PHOTO COURTESY OF RANDY JAYE.

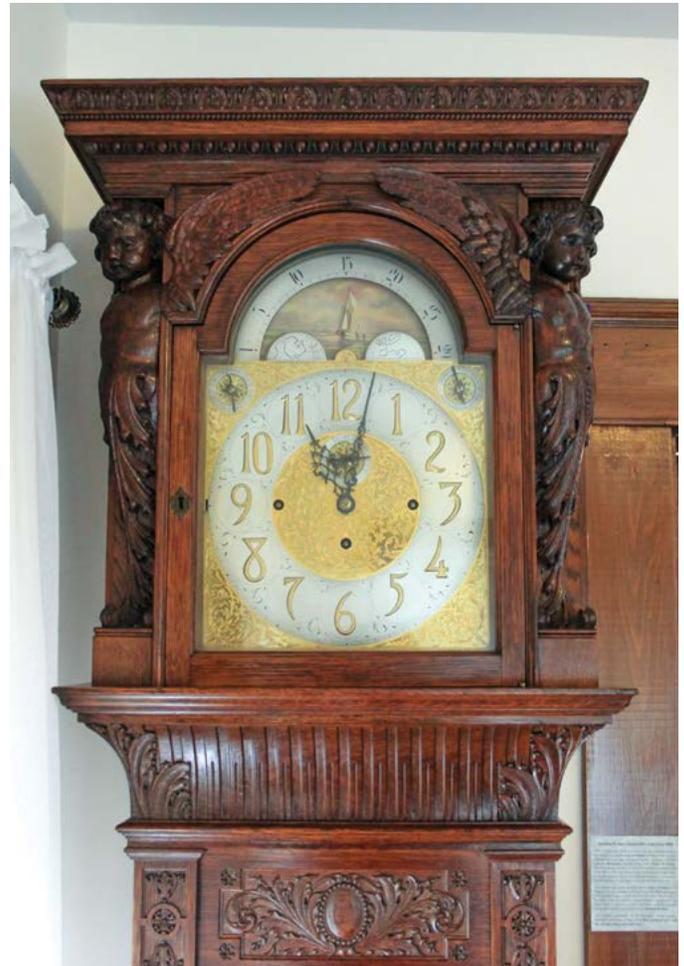
**Figure 4.** Front view of the hood and dial. PHOTO COURTESY OF RANDY JAYE.

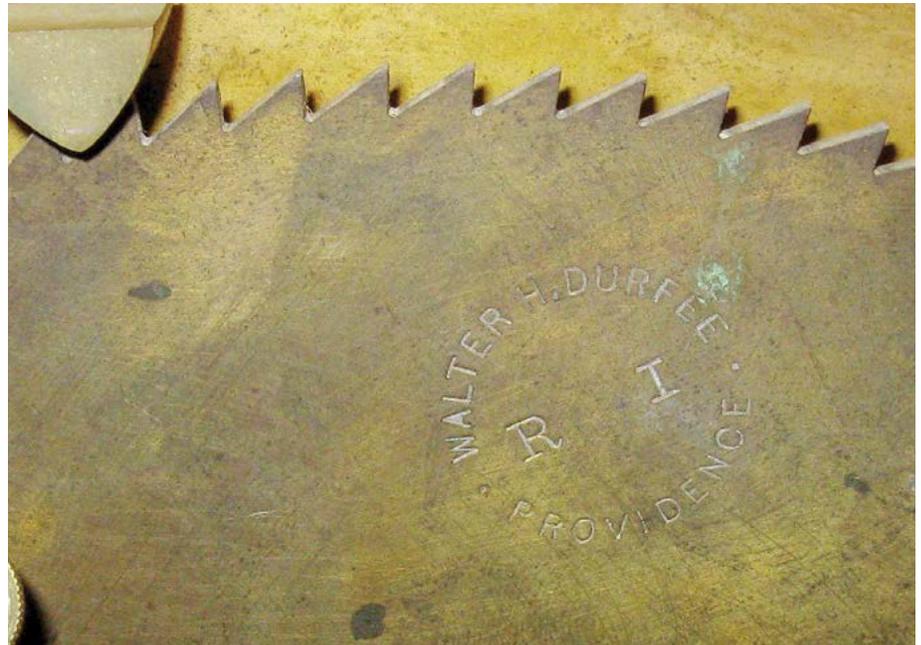
This clock's moon phase dial has the WALTER H. DURFEE, PROVIDENCE, RI circular stamp on the back (Figure 6), but does not have a Durfee stamp on the edge of the movement plate. This indicates that the

**Figure 6.** Walter H. Durfee, Providence, RI is stamped on the back of the moon phase dial. PHOTO COURTESY OF PETE SCHREINER.

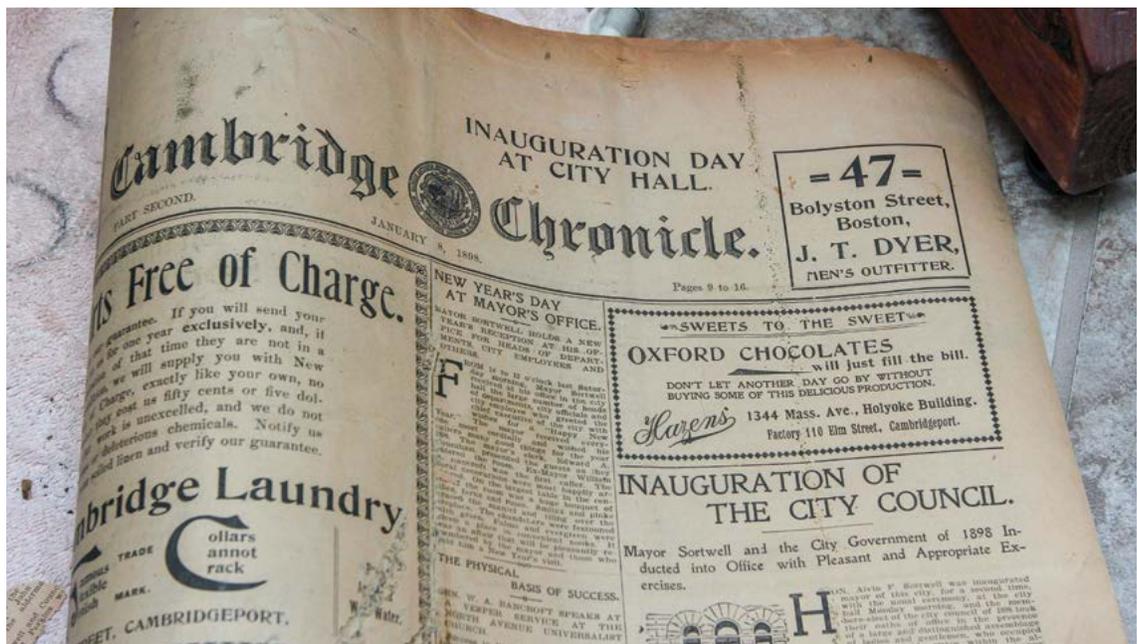
This clock was made circa 1898 as evidenced by both published references and newspaper lining (from the *Cambridge Chronicle* dated January 8, 1898) that was found inside the brass weight shells (Figure 7). The lead for the weights was most likely cast in the United States and fitted into the English-made brass weight shells that were then lined with local newspapers.

**Figure 7.** Newspaper lining from the *Cambridge Chronicle* dated January 8, 1898, which is in exceptionally good condition. PHOTO COURTESY OF PETE SCHREINER.

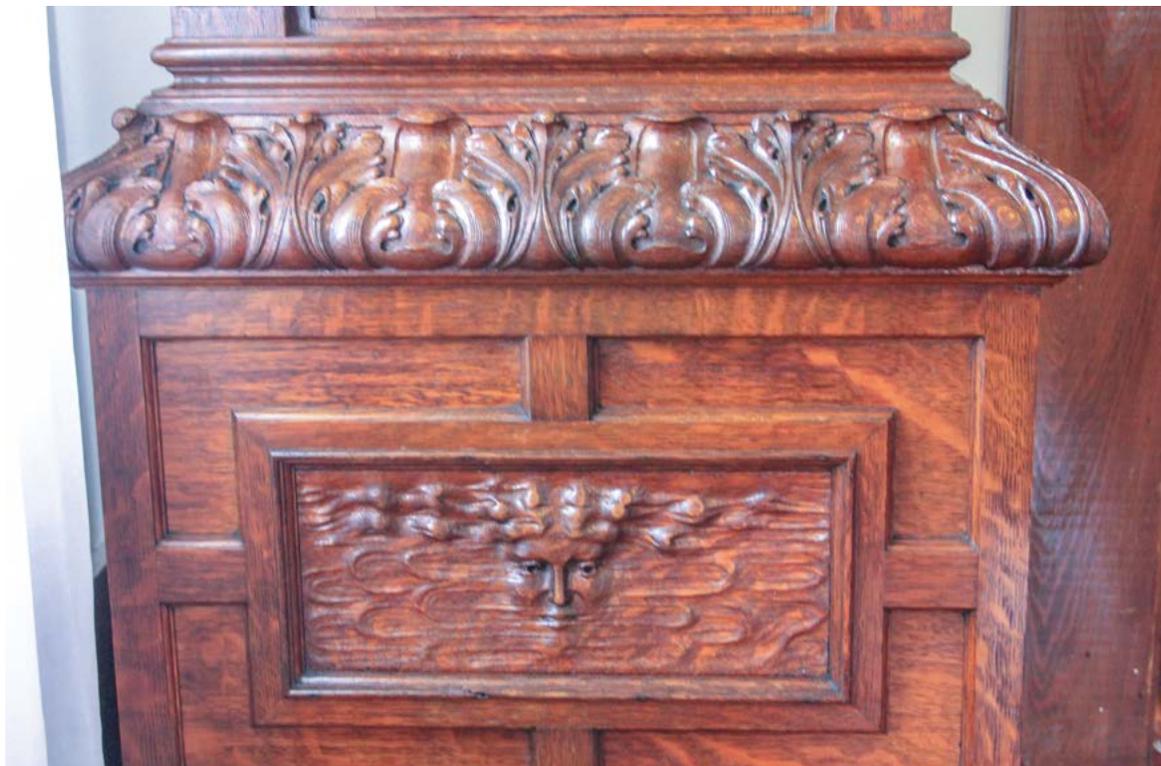
At a glance it is not apparent to most people, including some seasoned clock collectors and aficionados, that this clock has missing case parts because it is impressive in its current state. Originally, it had carved claw feet and a carved top section (with a depiction of the North Wind) that were most likely removed to stand the clock in a room with an eight-foot ceiling. The removal of these case parts sometimes occurred on clocks that were originally more than 8 feet in height. It is not unusual to discover that these parts have been discarded or lost over the years.

**Figure 8.** Detailed carvings on the base section with a depiction of the North Wind in the central panel. PHOTO COURTESY OF RANDY JAYE.

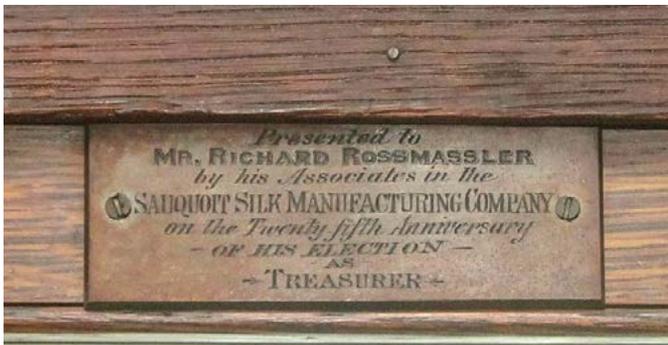
A presentation plate (Figure 9) that is attached on the inside of the clock's case is also interesting. It reads, "Presented to Mr. Richard Rossmässler by his Associates in the Sauquoit Silk Manufacturing Company on the Twenty-fifth Anniversary of His Election as Treasurer."

**Figure 9.** A presentation plate for Mr. Richard Rossmässler is attached inside the Holden House clock. PHOTO COURTESY OF PETE SCHREINER.
